CHIMNEYS, COMBUSTION APPLIANCE AND SMOKE NUISANCE

CASE STUDY 1

| | <u>Page</u> |
|---|---|
| 4) NACE official report and photographic evidence | 16 |

**Report on the Assessment of
Alleged Statutory Nuisance arising
from Smoke discharged from a
Flue at [REDACTED]**

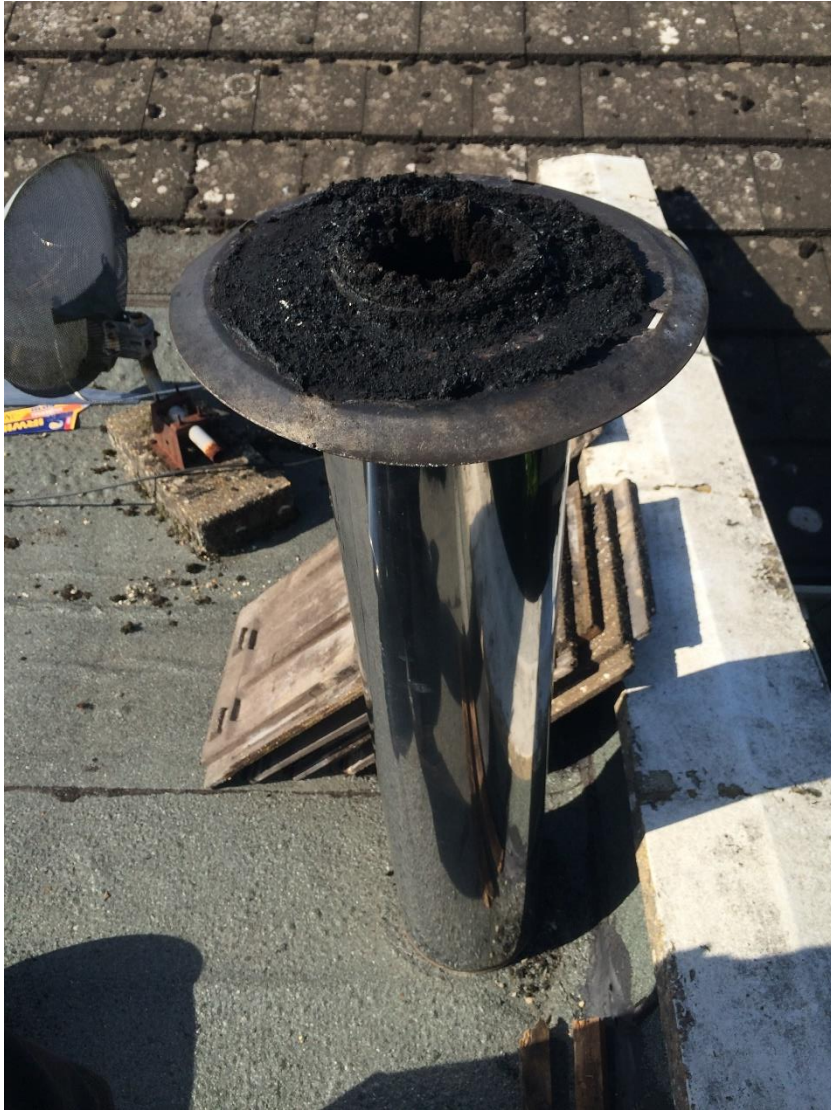
DEFECTIVE CHIMNEY COMPONENT

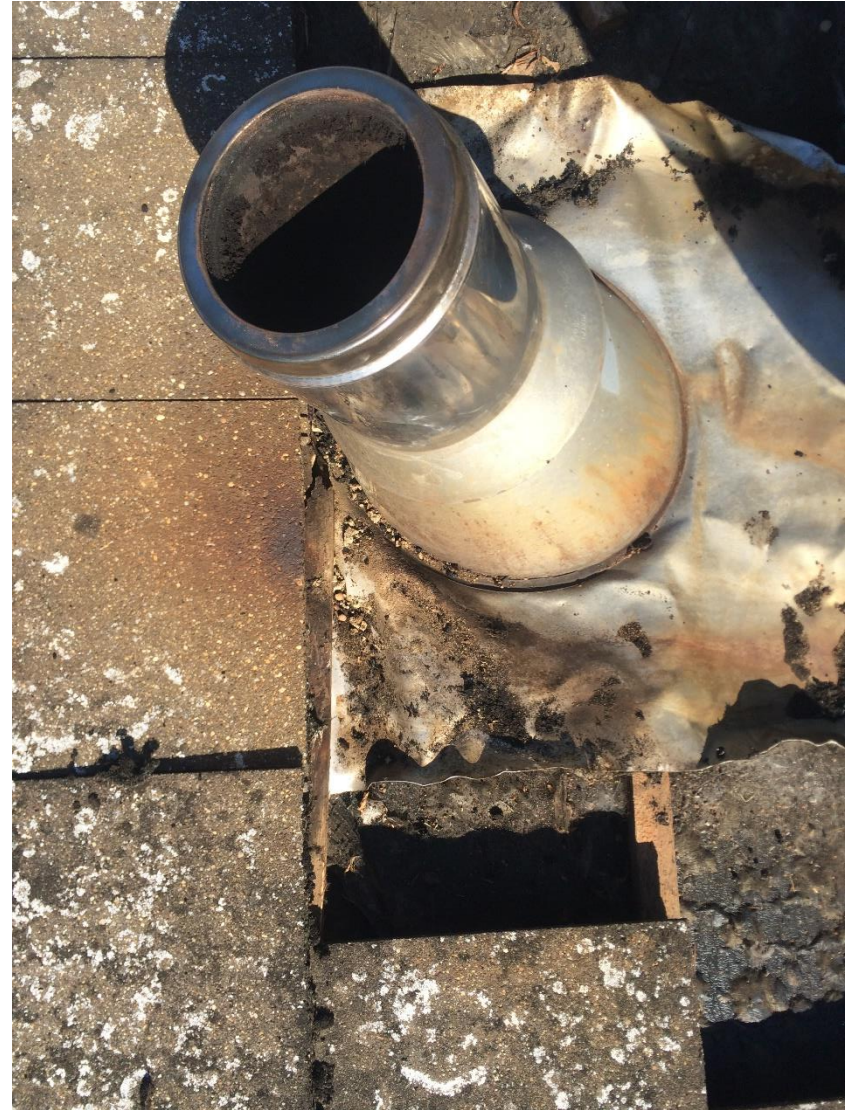
EVIDENCE OF FIRE DAMAGE TO TIMBER BATTEN

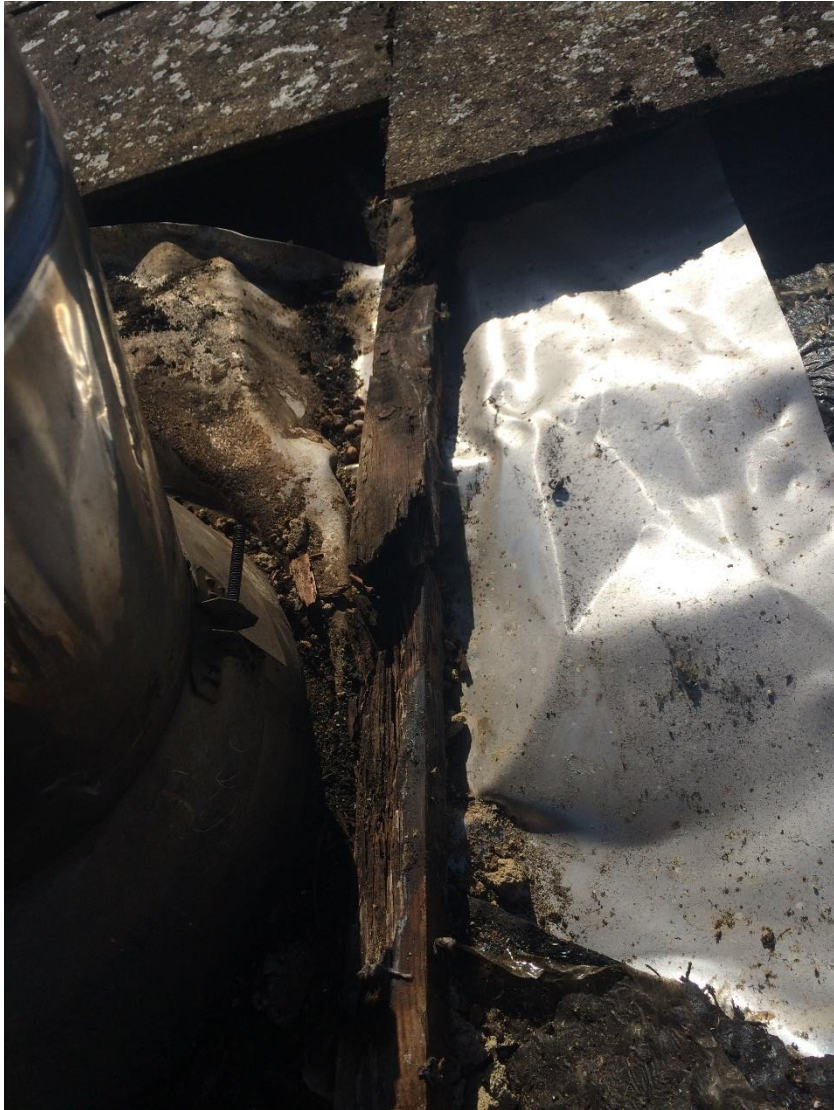
**FIRE DAMAGE EVIDENCE AND
BITUMINIOUS ROOF FELT**

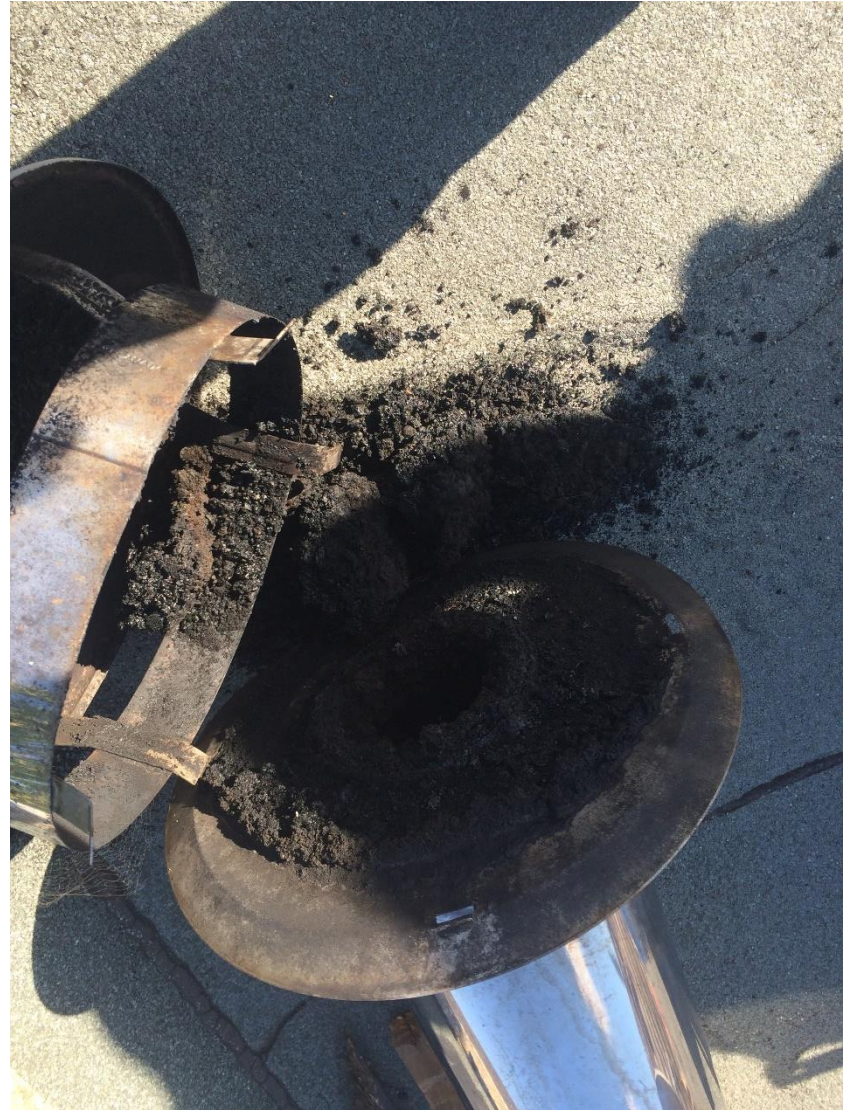
RESTRICTED COWL

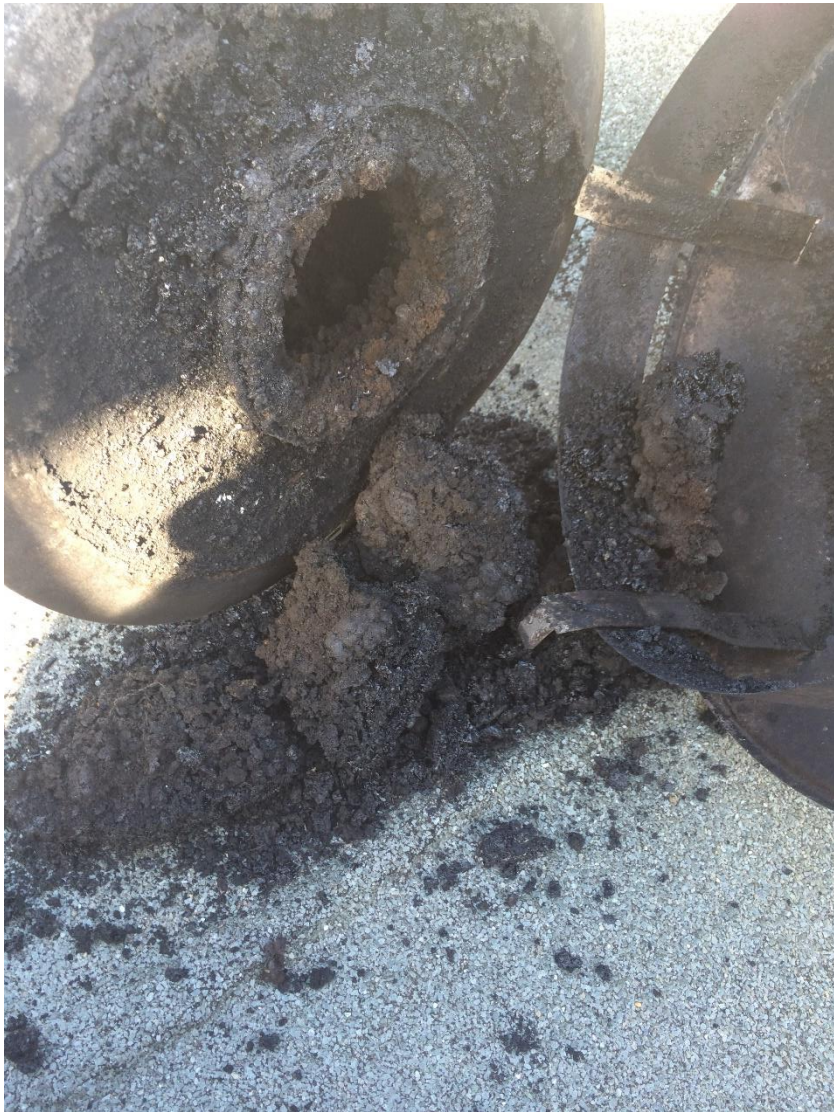
In view of any qualified information to the contrary, it must be accepted that a blockage or a restriction could have been in situ at the time of Mr. H inspection, leading to sufficient issues with draw and thus in the right atmospheric conditions spillage and / or excess smoking to occur.

RESTRICTED FLUE

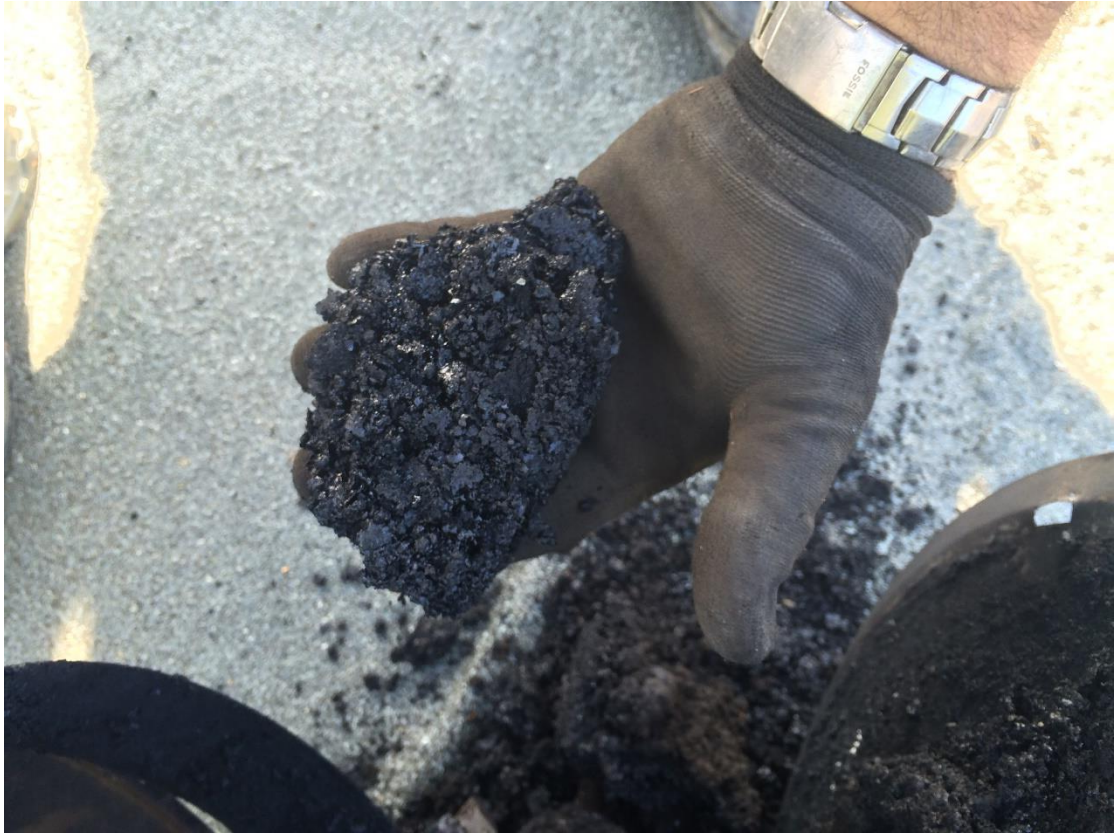
BITUMINIOUS MATERIAL REMOVED FROM FLUE

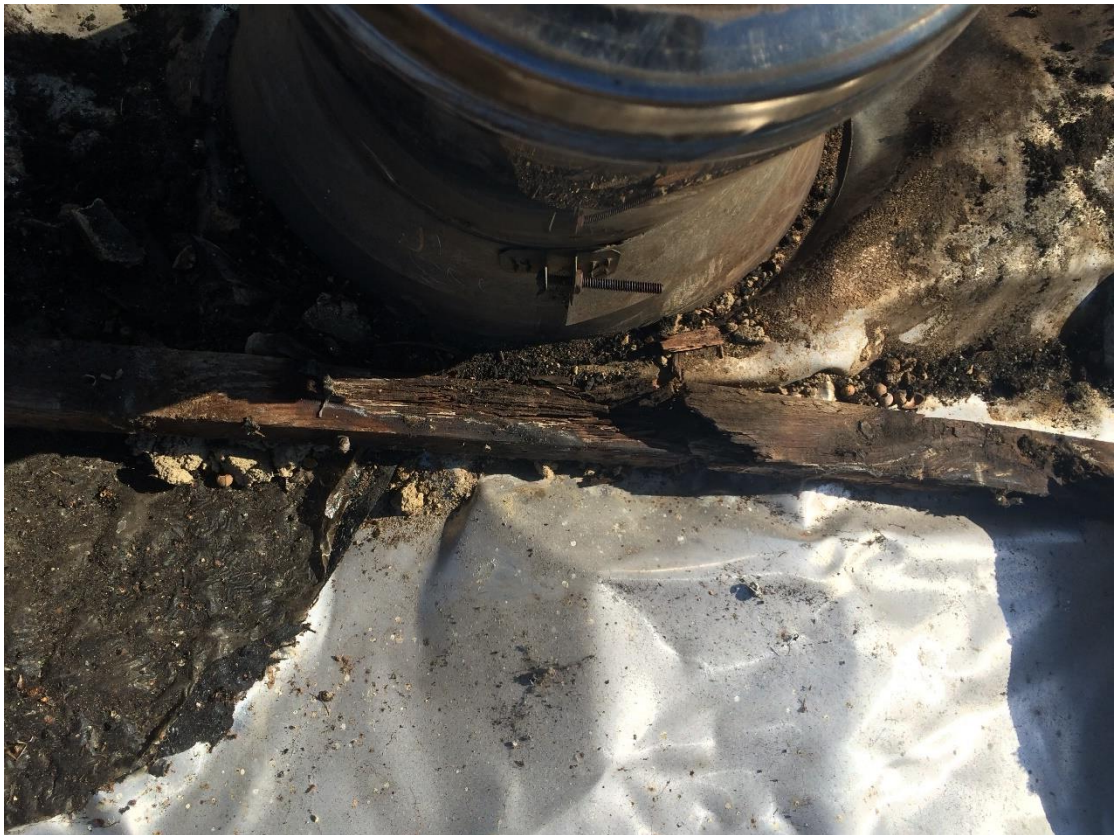
FIRE DAMAGE EVIDENCE

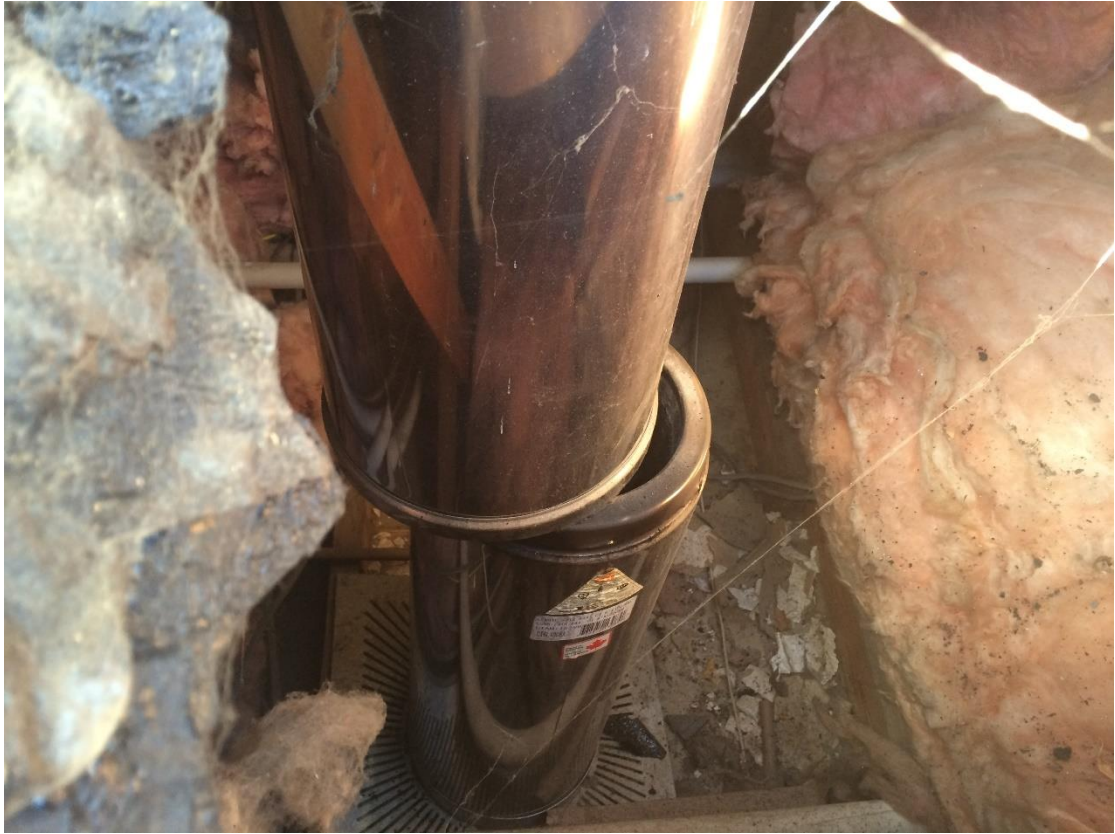
This particular Twin Wall chimney system is typical of many stainless steel variants some that are approved, many are not but readily available. Each section should have been twist - locked to the next with locking bands to hold the system in place, this could not be confirmed. The entire system appeared to be vertical and without any obvious mechanical faults. The chimney was terminated with an open rain guard in accordance with the majority of such manufactured systems.

LETHAL TWIN WALL CONNECTION

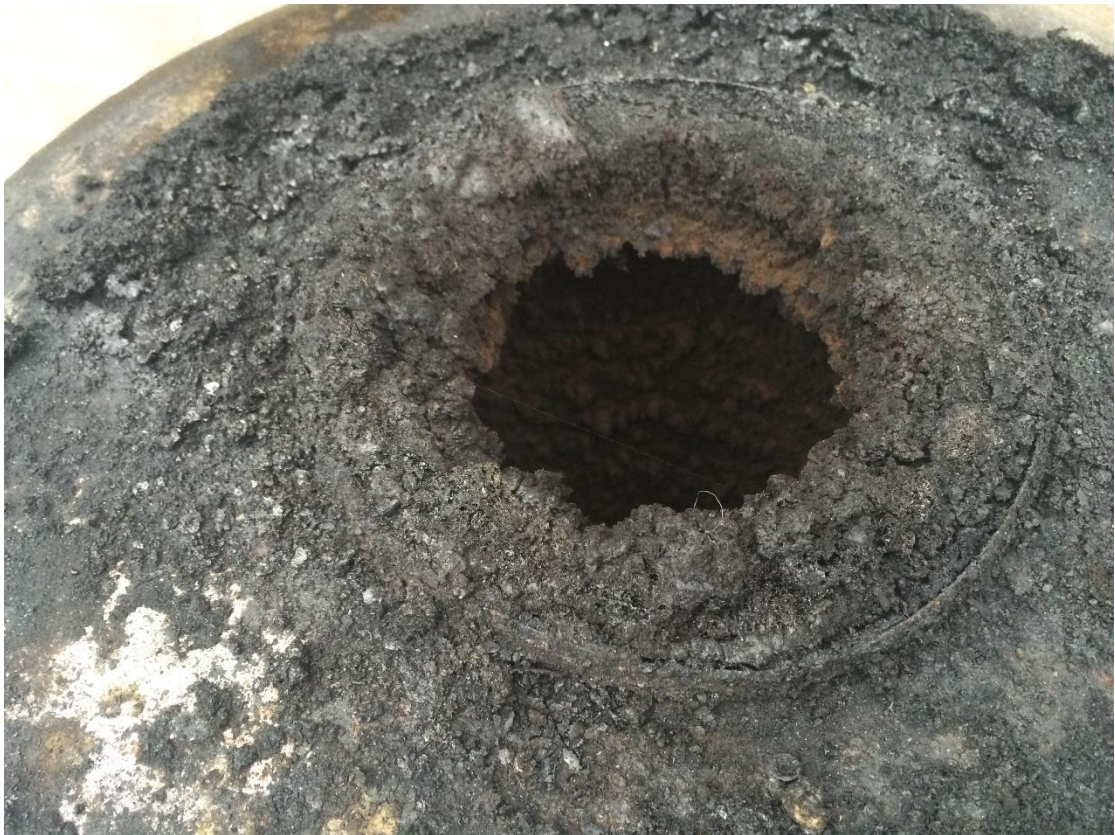
REDUCTION FROM 6 INCH TO LESS THAN 3 INCH

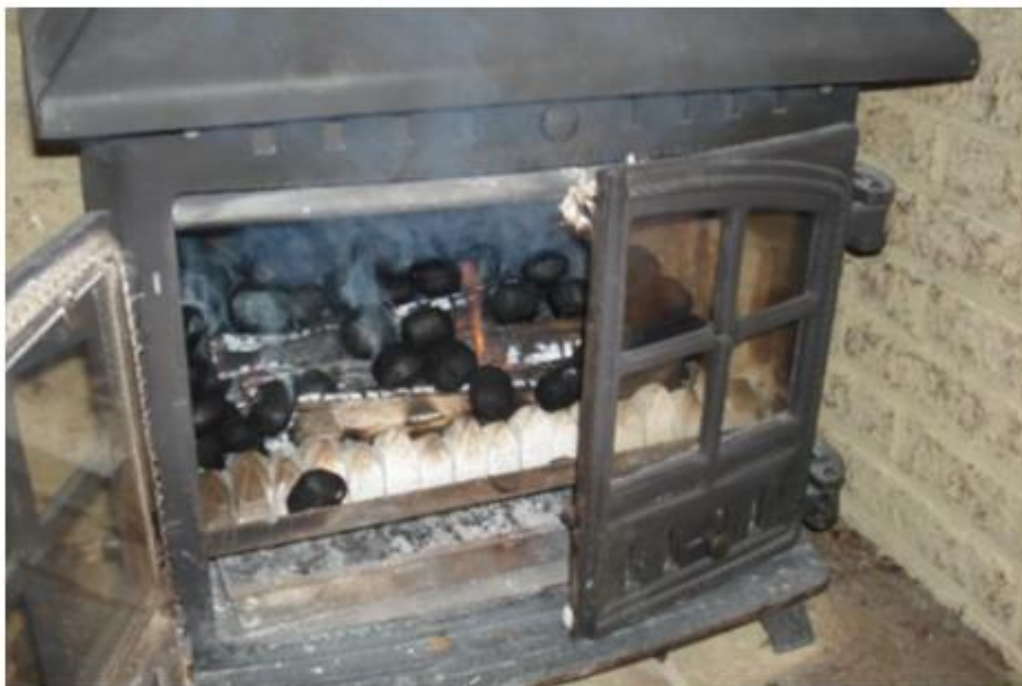
Appendix 1 Photographic Log

As you can see from the photograph above and as it was reported, "Phurnacite had been introduced and smoke was generated"

- D) It has been noted that "smoke" was generated as if to say this is out of the ordinary!
- E) I cannot confirm from the photograph, however the ash pan looks like it needs to be emptied, this would aid the flow of primary air.

- F) Again it is difficult to confirm from a photograph, however the fuel looks to be damp. Typically a deep shiny black colour would indicate a higher moisture content of a fuel. If the appearance was more grey in colour this would indicate lower moisture content.

Phurnacite is manufactured and is identified as a small ovoid-shaped briquettes with two parallel indented lines running longitudinally around the briquette (as pictured below) you can clearly see there is a distinct difference the fuel shown in the photograph.
