CHIMNEYS, COMBUSTION APPLIANCE AND SMOKE NUISANCE

CASE STUDY 1

| | <u>Page</u> |
|---|---|
| 4) NACE official report and photographic evidence | 16 |

**Report on the Assessment of
Alleged Statutory Nuisance arising
from Smoke discharged from a
Flue at [REDACTED]**

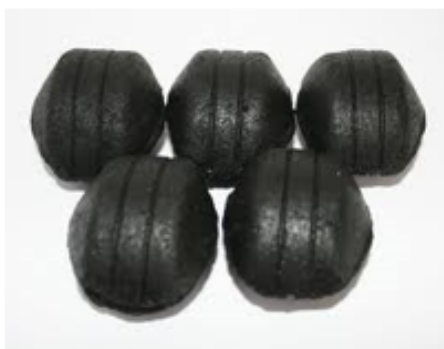
Phurnacite.

Phurnacite is manufactured and is identified as a small ovoid-shaped briquettes with two parallel indented lines running longitudinally around the briquette (as pictured below) you can clearly see there is a distinct difference the fuel shown in the photograph.
